PROJECT PROFILE

REHABILITATION OF FOSSIL-FUEL POWER PLANT INFRASTRUCTURE

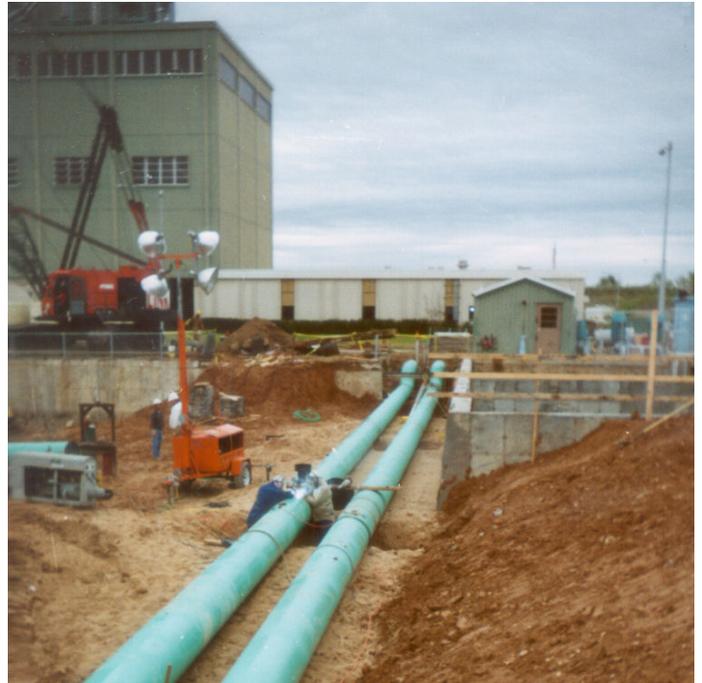
Shallow utility realignment following reconstruction of the cooling water intake canal to address structural distress and Asian clam infestation.

Work on the intake canal included evaluation of vertical displacements that had reached 24 inches and assessment of problems associated with Asian clam infestation. The clams were plugging the plant's condensers and piping systems causing unplanned outages.

D'Appolonia developed a remedial design for the intake canal that included new 28-foot-high concrete transition structures and a pair of 11-foot-diameter intake pipes. The new design eliminated the use of all components of the existing canal that had been distressed by the expansion of the underlying soils. The modified hydraulics of the reconfigured structure increased cooling water flow velocities and eliminated the Asian clam problem.

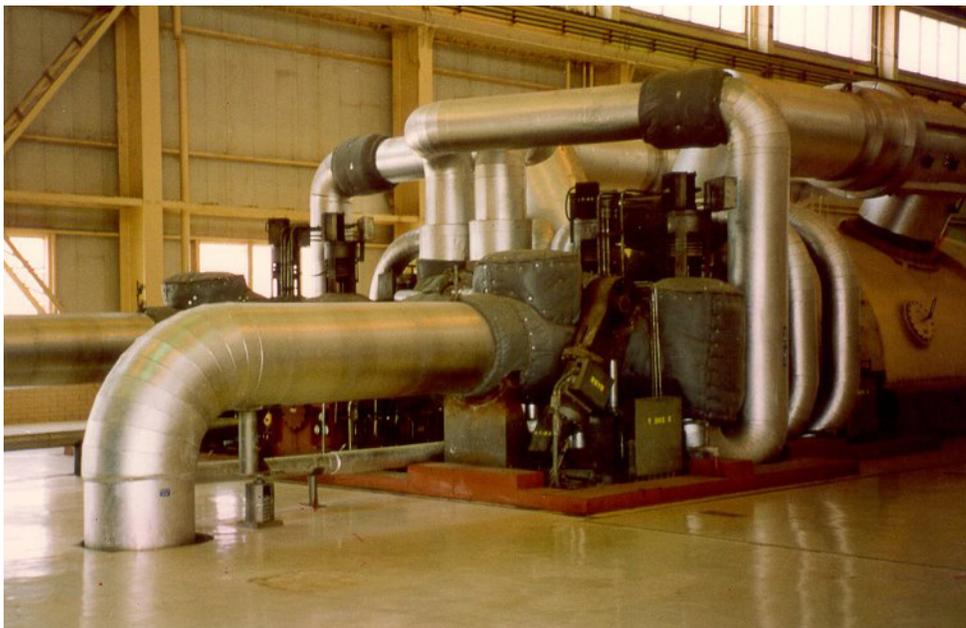
During the plant's service life, the 110-foot-long by 42-foot-wide turbine pedestal had tilted 6 inches due to differential movement of expansive soils supporting the pedestal foundation. To assess the magnitude of pedestal movements since plant construction, historical survey records were reviewed. Survey control was implemented and instrumentation was installed to monitor movements in the foundation soils and structure components. Survey control was provided by monuments that were

This 110-foot-long by 42-foot-wide turbine pedestal had tilted six inches due to differential movement from underlying expansive clay soil.

Instrumentation and testing data indicated that future foundation movements would be minimal. Structural analysis of the piping systems indicated that although the piping was locally overstressed, the systems could be repaired by realigning pipes to near their original configuration and installing new hangers/supports to accommodate system movements during plant operation. Therefore, rather than costly and time consuming pedestal foundation modifications, the repairs in the power plant were limited to realignment of the piping systems supplemented with long-term monitoring of structure and foundation movements.
