# REAL TIME RESPONSE TO THE LANDSLIDE AT THE LEXINGTON APARTMENTS

Michael J. Marasa, P.E.<sup>1</sup>, John R. Wolosick, P.E.<sup>2</sup> & Bradley D. Campbell, P.E.<sup>3</sup>

**Abstract:** In late February, 2003, a steep hillside behind three apartment buildings near Nashville, Tennessee displayed signs of instability. Evidence of movement was noted as small bulges emerged in various places along the slope. In the following days, additional movement was observed and the residents from 70 units were evacuated and relocated.

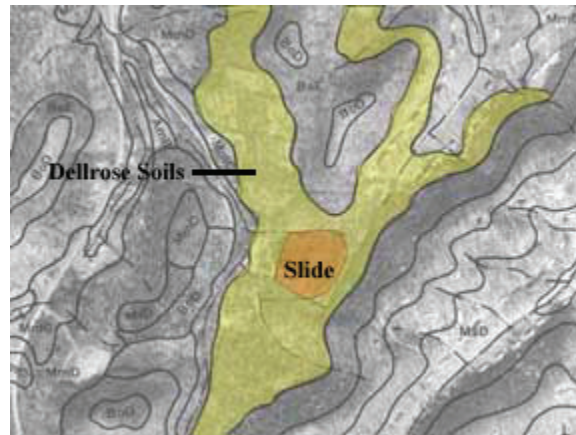
Department of Agriculture are often a very reliable indicator of colluvial soils. In this case, the Dellrose soils contain many of the characteristics of colluvium produced by the geographically higher parent bedrocks. As can be seen in Figure 1, the landslide occurred well-within the boundaries of the mapped Dellrose soils.

**Figure 1.** Geologic setting

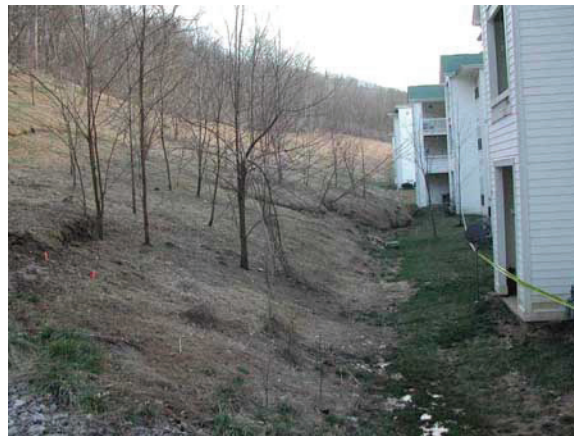
Other early warning signs and historical evidence of previous slides were noted along the hillside. An older roadbed that transected the hillside and bounded on each end by very deep drainage swales was very likely a graben, or wedge shaped plunge into the subsurface at the upper end of a significant, historical slide. The character of the upper end of the current slide was nearly identical in its early stages to the nature of that feature. As the slope began to seep water and initiate small bulges, a 2 to 3 foot scarp became evident approximately 450 feet up the hillside.

**Figure 2.** Early warning signs, small bulges in the slope.

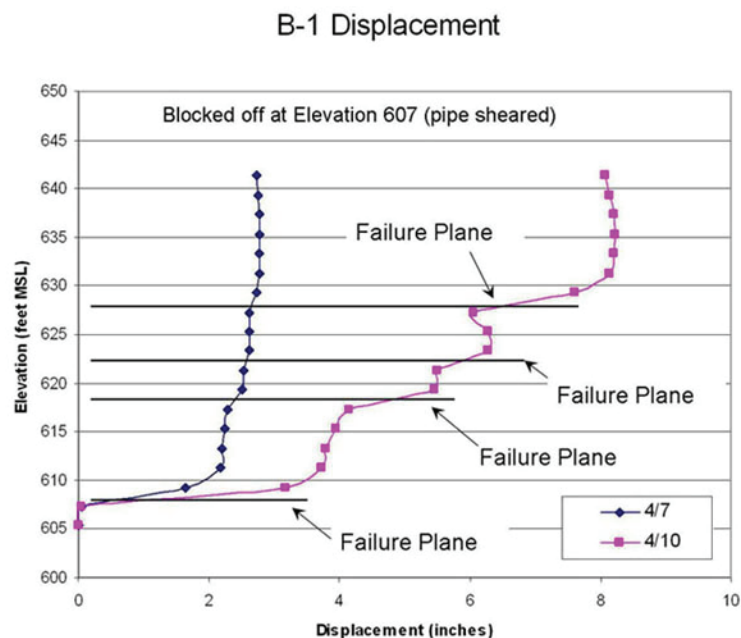
The initial geotechnical investigation of the slope consisted of conventional borings and test pits within the slide area. A copy of the original geotechnical report was also reviewed for pertinent information. Topographic and geologic maps were studied and a set of aerial photographs were taken to study the area in detail. A survey crew was mobilized to record changes in the slope surface and to map the location and extent of visible tension cracks. Inclined meters were installed into bedrock in most of the borings and readings were taken almost immediately. Feedback as to the depth of slide planes was almost instantaneous. Unfortunately, the life span of the slope inclinometer casings was very short with most of the casings deflected beyond use within one week (Figure 3).

**Figure 3.** Typical slope indicator results

Nonetheless, the zones of movement identified in the inclinometers enabled an estimate of soil parameters by back-calculation using the profiles developed with the recently acquired data.

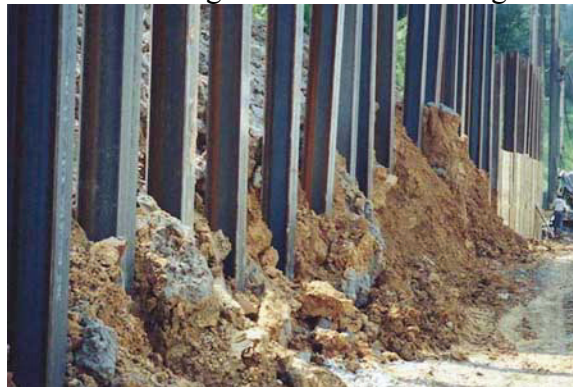
The initial plan was to stabilize the entire slope with ground anchors. The number and location of anchors was being developed as the slide began its accelerated movement. Consequently, the construction of a temporary soldier beam and lagging wall was initiated to slow the progress of the slide and protect the buildings until the ground anchors could be installed. Figure 4 illustrates the advancing slide materials during wall construction.

**Figure 4.** Soldier Beam and Lagging Wall

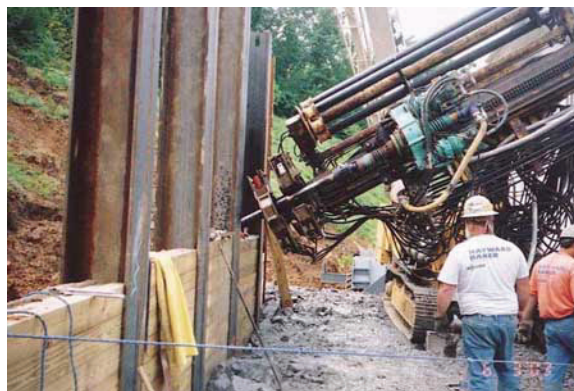
However, as the magnitude of the slide grew, it became necessary to make the wall a permanent feature and include tiebacks for added stability, as shown in Figure 5. The resulting final design is illustrated on Figure 6.

**Figure 5. Permanent Wall**

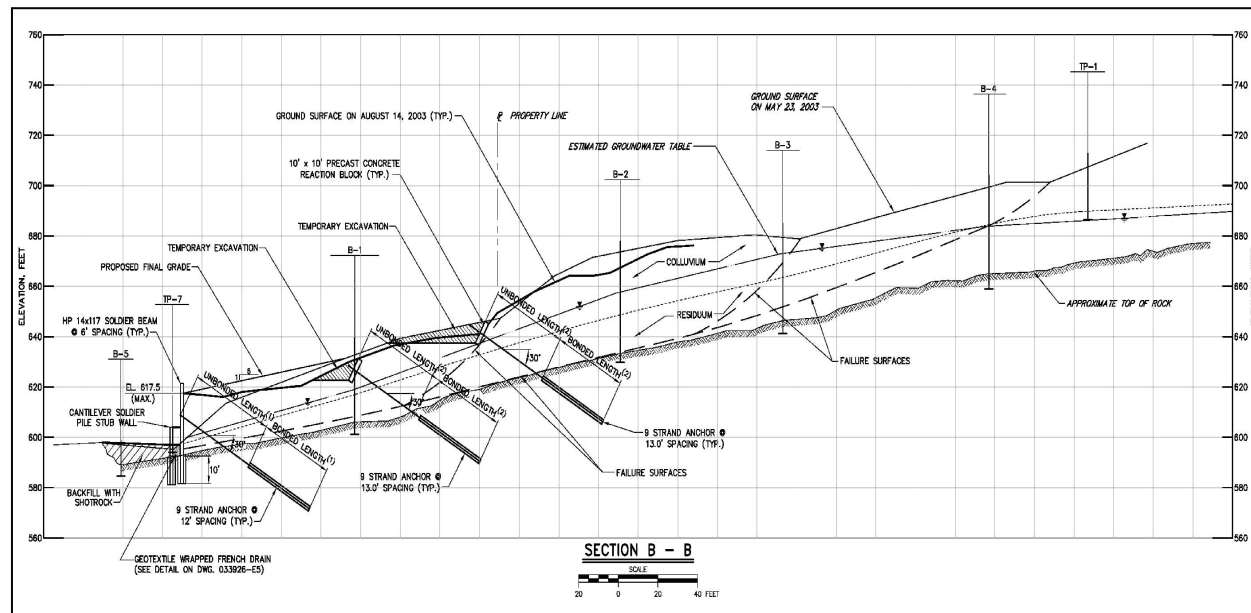
**Figure 6. Cross-Section of Final Landslide Repair Scheme**

A temporary shot rock berm was placed in front of the soldier beam and lagging wall to create a buttress for short term support and also provide a working platform for the installation of tiebacks. When the adjacent landowners decided not to participate in the repair, the solution had to be modified to be constructed entirely on the apartment complex property. Two additional rows of ground anchors above the wall were analyzed and deemed satisfactory provided that a subsurface easement was obtained and the top row of anchors was allowed to extend onto the adjacent property. A small cantilever soldier pile stub wall was constructed in front of the anchored soldier pile wall to provide additional support at locations where the soldier beams were distressed by slope movements prior to installation of the anchors. Other ancillary features to the anchors and wall included several rows of subsurface drains and several tiers of surface

ditches to divert water around the repaired area. In addition, the surface drainage in front the wall was considerably improved.

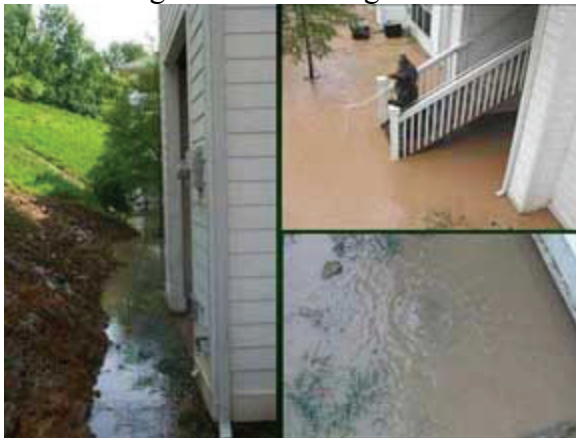
As shown in Figures 7 & 8, the movement of the slope blocked surface drainage behind the units and significant flooding occurred inside several of the ground floor apartment units.

**Figure 7.** Flooding

Pumps were installed to control the accumulating surface water. Also during this time, the utility companies were notified to disconnect service behind the buildings. The gas company was resistant to do the disconnect believing that their plastic lines would be flexible enough to tolerate the movement. Following the insistence of the ownership team, the service was isolated from the area just before the “flexible” gas line was sheared.

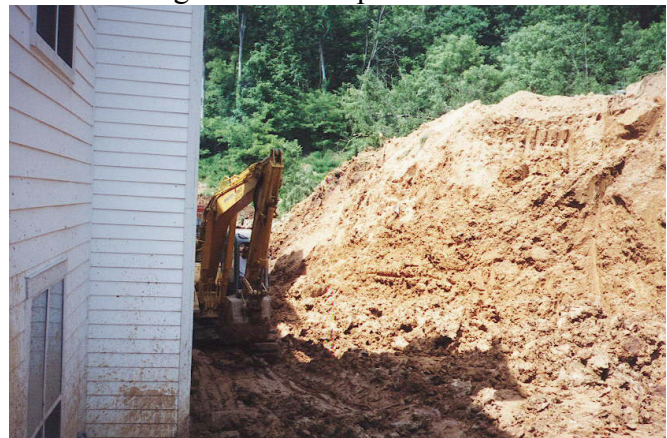
**Figure 8.** Emergency excavation of slide material

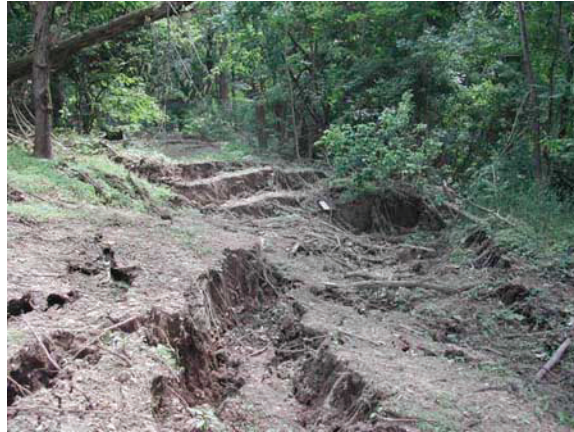
The design process required consideration of the progressive failure (Figure 9) that was occurring in the slope.

**Figure 9.** Surface expression of progressive failure

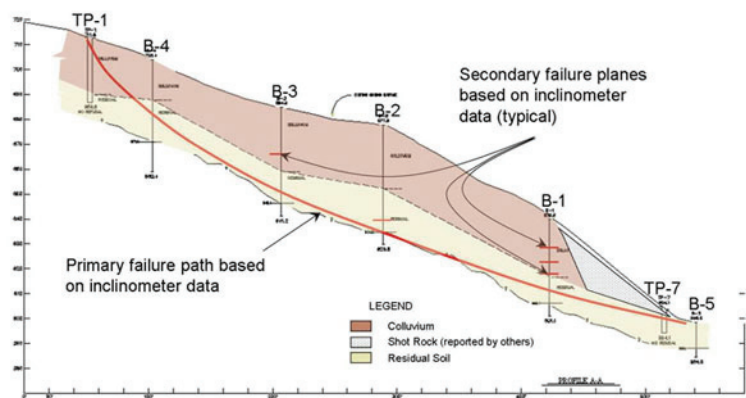
Analysis was additionally complicated by the changing geometry of the slope as it moved downslope. The interim profile presented in Figure 10 illustrates some of the subsidence in progress in the higher elevations with corresponding bulging occurring in the lower slope.

**Figure 10.** One of the many profiles of the slope geometry developed as the slide progressed

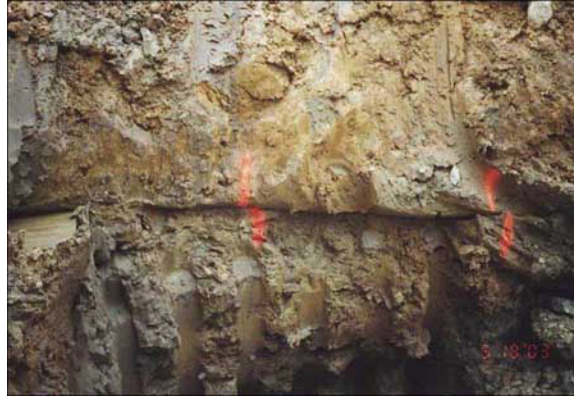
The most effective parameters used for analysis were derived from back calculation using the location of the slide plane from the inclinometers and the slide surfaces exposed in the construction, such as the failure surface seen in Figure 11.

**Figure 11.** Exposed Slide Plane

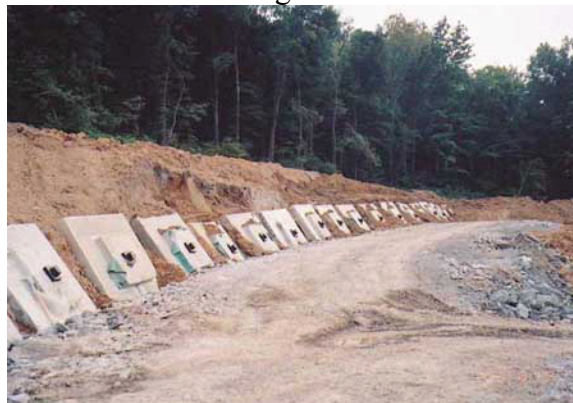
**Figure 12.** Finished Anchor Blocks

The parking lot provided a convenient staging area for the equipment and materials. An assembly line for construction of pre-cast anchor blocks (Figure 12) and lagging panels supported the field activities behind the buildings.
