# PROJECT PROFILE

## FOUNDATION DESIGNS FOR CEMENT PLANT STRUCTURES IN KARST TERRAIN

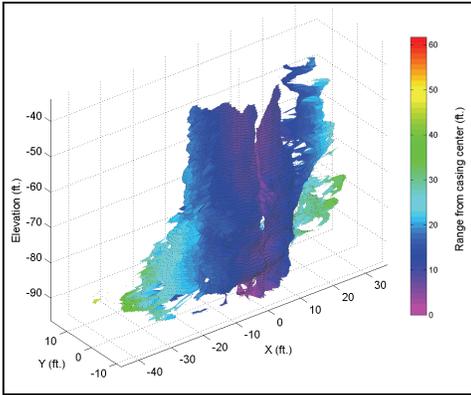
*3D image of subsurface void created through laser mapping.*

D'Appolonia conducted sonar and laser mapping of large voids that were encountered beneath one of the silos to establish the extent. The existing voids were filled with 1,400 cubic yards of

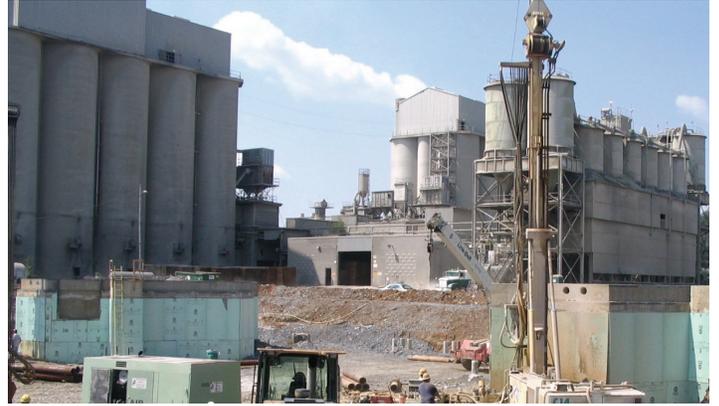
*Micropile installation for Finish Mill foundation.*

concrete. For the majority of the large, heavily loaded structures, high capacity micropile deep foundations were designed. To improve rock quality, Low-mobility grout was injected at pile locations where broken rock and cavities existed, and pile load tests confirmed the design adequacy of the load carrying capacity for representative pile/rock conditions.
