PROJECT PROFILE

DESIGN OF REHABILITATION MEASURES FOR WISECARVER RESERVOIR DAM

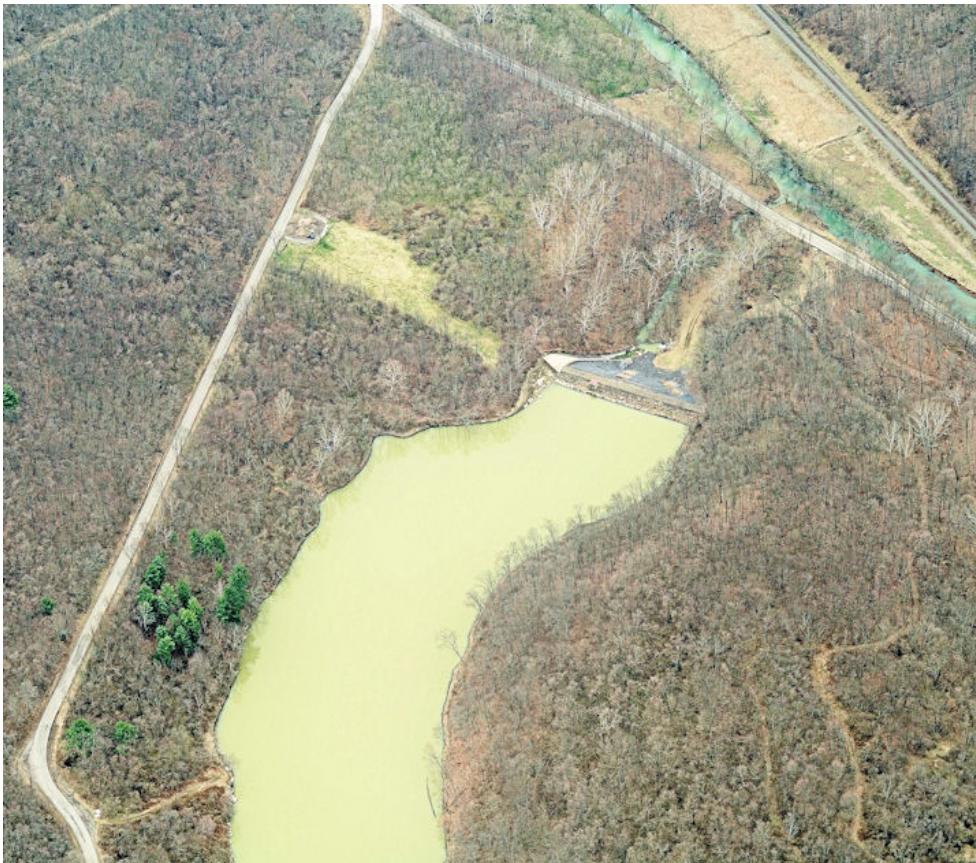
Aerial view of Wisecarver Dam and associated spillway and impoundment.

The dam was originally constructed in 1931 and consists of an earthen embankment about 40 feet high and 260 feet long with a reinforced concrete spillway located along the left abutment. The downstream and upstream slopes are 2 horizontal to 1 vertical (2H:1V), and 2.5H:1V, respectively. Based upon the original design drawings, a clay puddle foundation cutoff trench is centered with the upstream limits of the crest.
