# PROJECT PROFILE

## REMOTE SENSING OF FORESTLAND ABOVE LONGWALL MINING AREAS

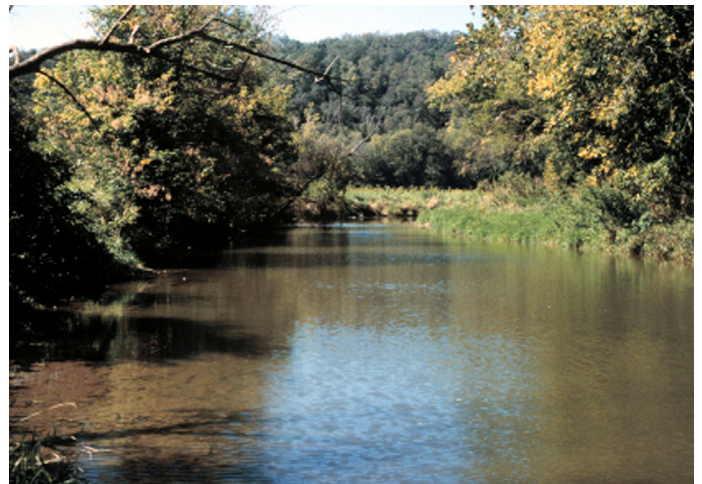
Pool created by mine subsidence where field survey was conducted.

Areas of potentially stressed tree canopy identified from the imaging analysis were targeted for ground truthing to verify that they were actually stressed and to determine the cause of the stress. Additional areas associated with subsidence pools along a stream and longwall panel boundaries where high tensile strains were predicted were also surveyed.
