PROJECT PROFILE

SPILLWAY REHABILITATION AND DAM IMPROVEMENTS

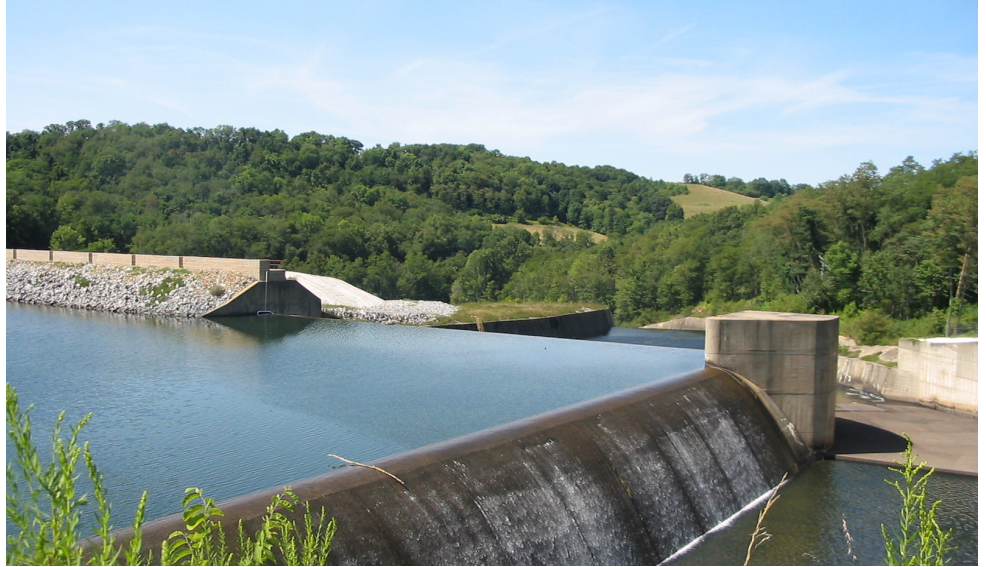
Raised crest and new armored spillway channel embankment at Quemahoning Dam.

In addition to spillway rehabilitation, D'Appolonia prepared designs for rais-

ing the spillway crest (to gain additional spillway capacity) and for raising and protecting the channel embankment along the spillway. The work scope also

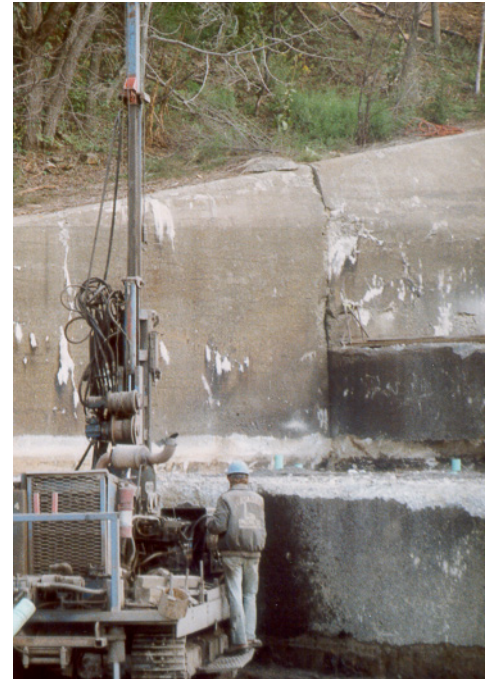
Anchor installation at spillway step.

A flood event in January 1996 resulted in major damage to the emergency spillway. Floor slabs located at the downstream end of the spillway were displaced by the flood. D'Appolonia designed replacement slabs to be more resistant to displacement and more durable. This was achieved by utilizing slabs of increased mass and rigidity, and by anchoring the slabs to underlying bedrock and doweling them to the massive lateral spillway walls.

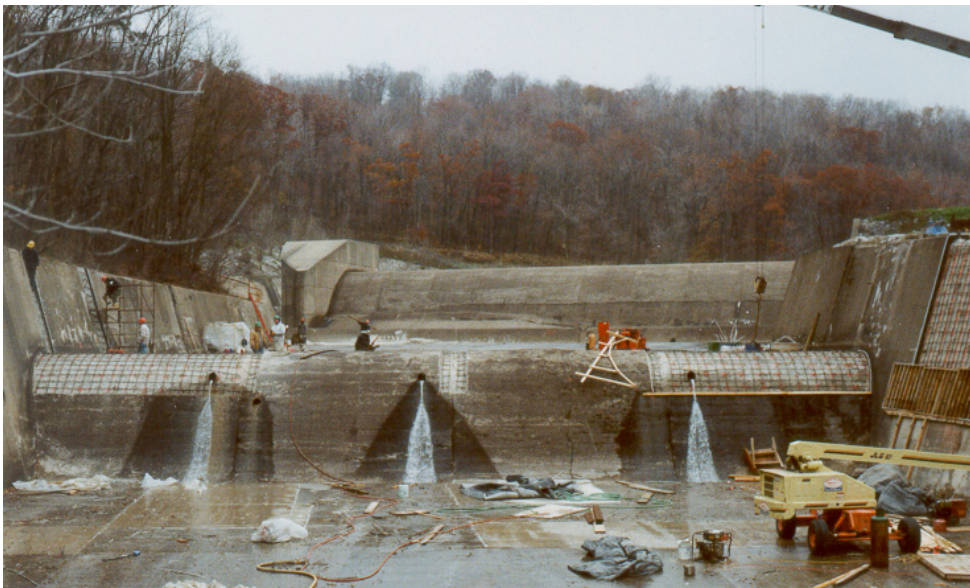
Rehabilitation work in progress on the Quemahoning Dam emergency spillway.

In areas where the floor slabs were relatively thin, the existing concrete was removed and replaced with bedrock-anchored, cast-in-place concrete. The thicker concrete floor slabs, the walls and one weir were repaired by chipping out weathered concrete and replacing it with concrete overlays that were anchored to underlying sound concrete. The weir repair and some of the wall repairs were made using steel mesh-reinforced shotcrete. The spillway repair work was completed in 1997.
