# PROJECT PROFILE

## EMERGENCY FOUNDATION SUPPORT AND LONG-TERM STABILIZATION

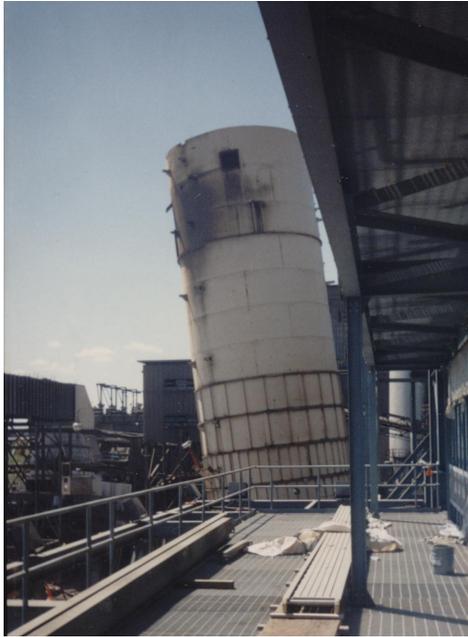
Storage tank exhibiting tilt resulting from foundation failure caused by collapse of subgrade cooling pipes.

D'Appolonia was retained by the utility to develop and manage the implementation of emergency remedial measures to temporarily support and eventually to relevel many of the affected structures. This work included support of structures adjacent to a 60-foot-deep and 50-foot-wide excavation made to replace the failed cooling water intake pipes.

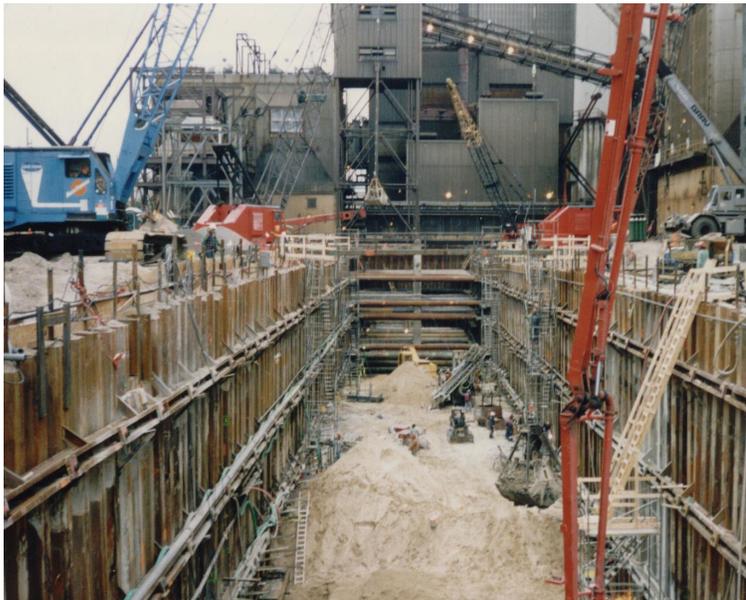
Sheet pile wall used for ground support during replacement of failed 14-foot-diameter cooling pipes located 60 feet below grade.

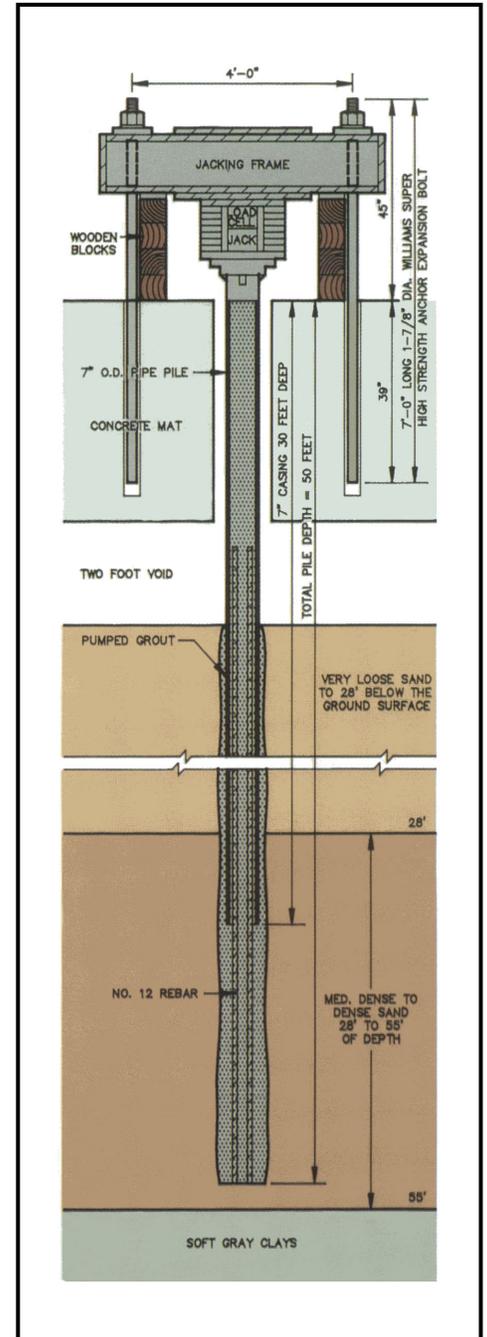
Micropile support system used to relevel structures affected by pipe collapse.

The primary support system for the largest structures affected by the failure consisted of micropiles installed through one-foot-diameter holes drilled through foundation mats of the affected structures. Reaction frames were positioned above the piles and anchored into the mats using 2-inch-diameter rock bolts. Jacks and load cells were placed between the pile caps and the reaction frames to facilitate support and leveling of these structures, which were sensitive to differential settlement and nonuniform loadings.
