PROJECT PROFILE

FORENSIC ANALYSIS OF FOUNDATION MOVEMENTS AND REMEDIAL DESIGN

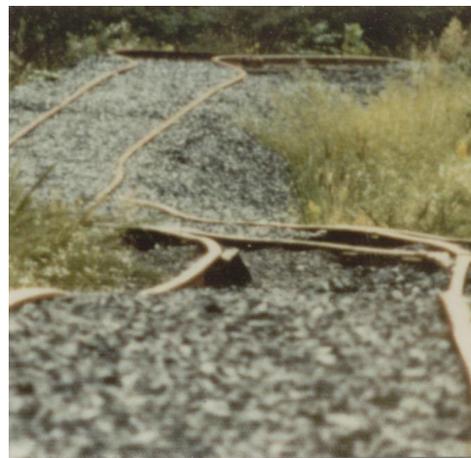
Observed offset in site railroad track caused by movement of slope.

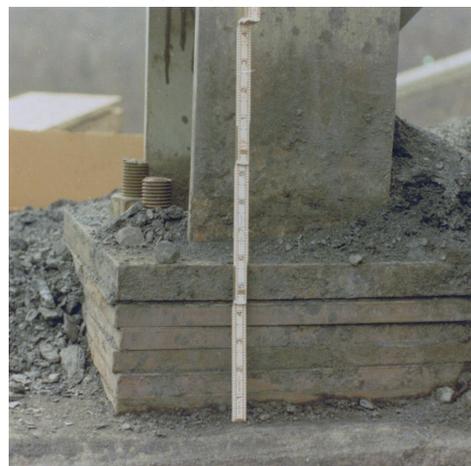
Shims placed beneath column supports for a 100-ton storage/truck loading bin.

The above measures were employed to control water levels in the colluvial soils responsible for the slope failure. As movements were brought under control, structures were monitored to determine when foundation movements ceased. When the movements became negligible, remedial designs to restore structures affected by foundation movements to their original condition were prepared by D'Appolonia and subsequently implemented by the owner.

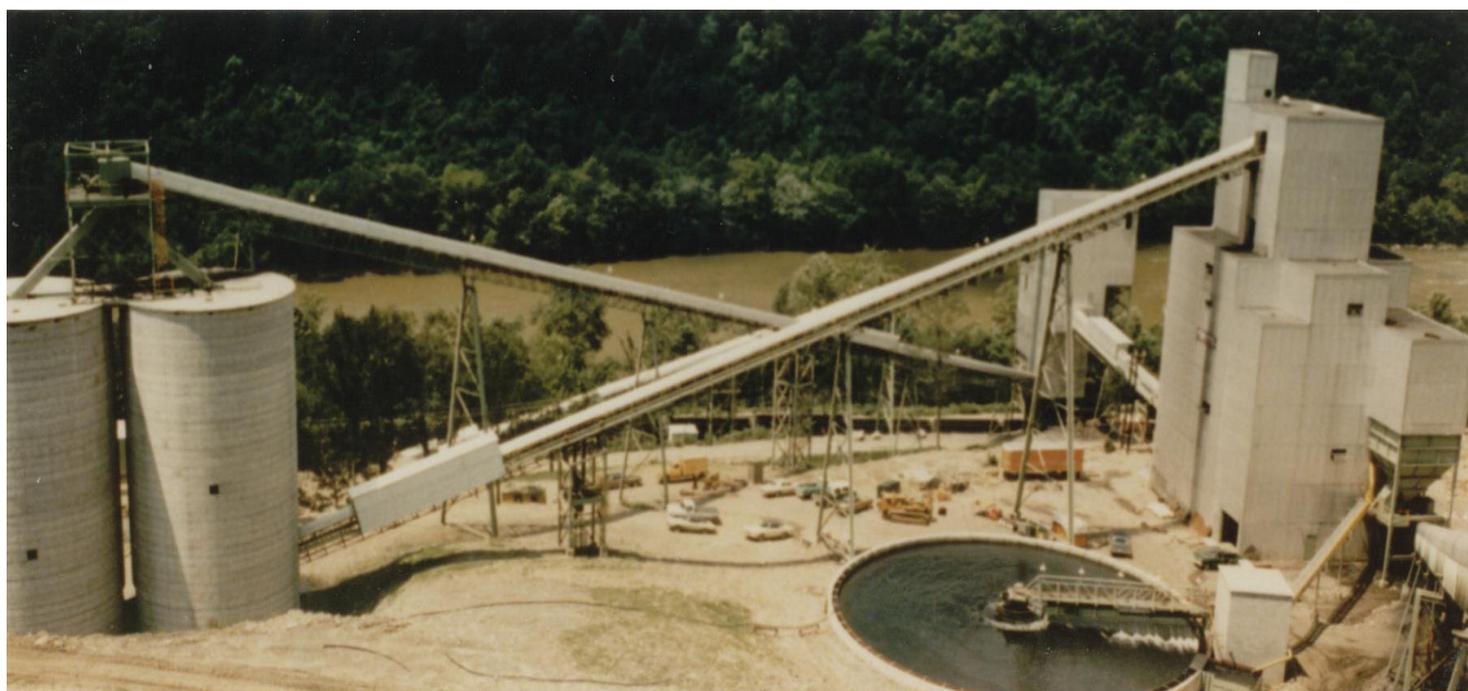
Major site structures for coal preparation complex located in the New River Gorge.
