PROJECT PROFILE

ENVIRONMENTAL ASSESSMENT OF THE BLACKWOOD MINE SITE

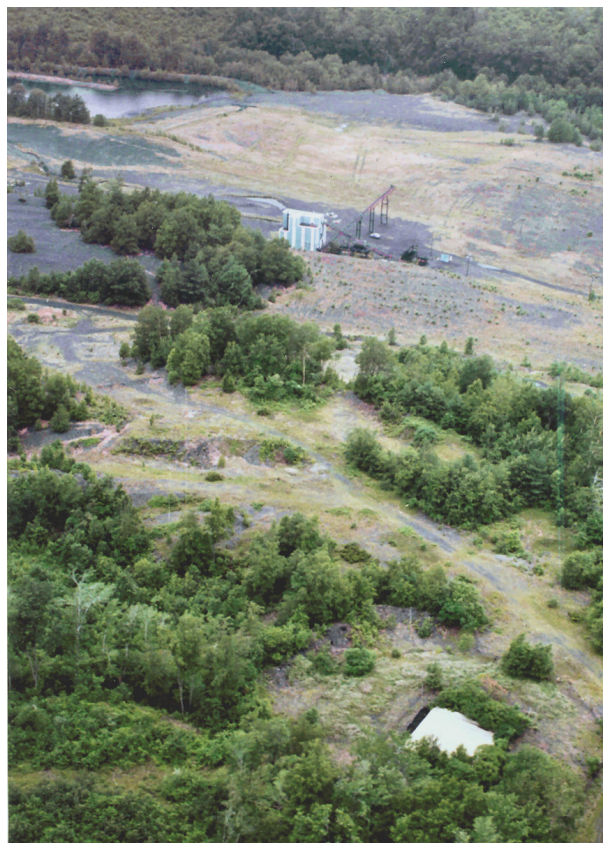
Aerial view of the Blackwood Mine Site at the time of the study. The building is an abandoned coal breaker. The square concrete pad in the foreground covers a deep ventilation shaft to the mine, but the sides of the pad partially collapsed, requiring further remediation.

Subsequently, in 2003, D'Appolonia was retained by the Bureau of Abandoned Mine Reclamation (BAMR) of the Pennsylvania Department of Environmental Protection (PADEP) to prepare a reclamation design for the Blackwood property. The scope of work for this project included permanent sealing of the deep ventilation shaft. The reclamation plan has been under regulatory review, and we anticipate that construction work associated with reclamation of the Blackwood property will commence in 2006.

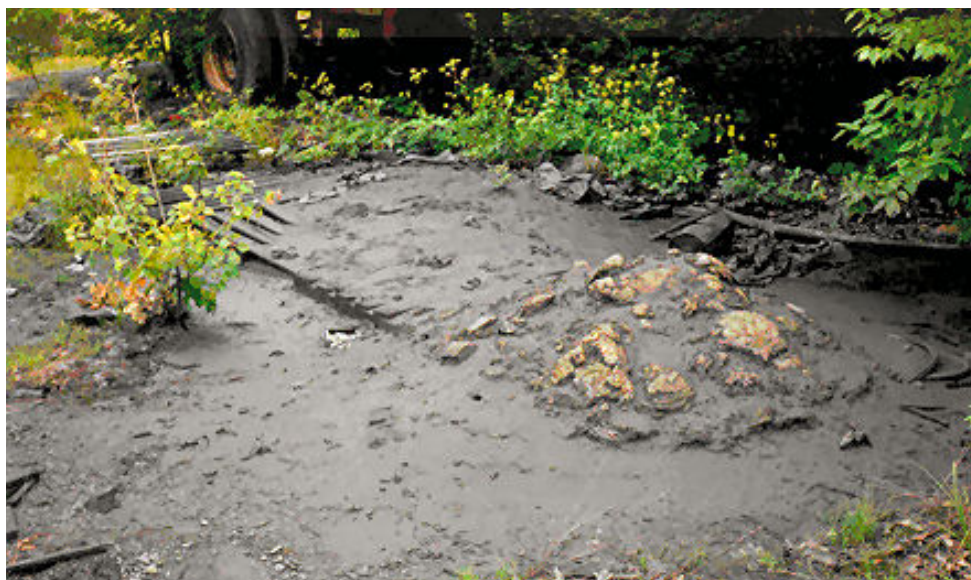
Organic sludge spilled on the ground surface near the breaker building at the abandoned Blackwood Mine site.
