PROJECT PROFILE

INVESTIGATION/REMEDICATION OF SEEPAGE CONDITIONS AT EAST BRANCH DAM

D'Appolonia performed a comprehensive geotechnical exploration at the East Branch Dam located on the East Branch of the Clarion River in Elk County, Pennsylvania, for the Pittsburgh District of the U.S. Army Corps of Engineers (USACE).

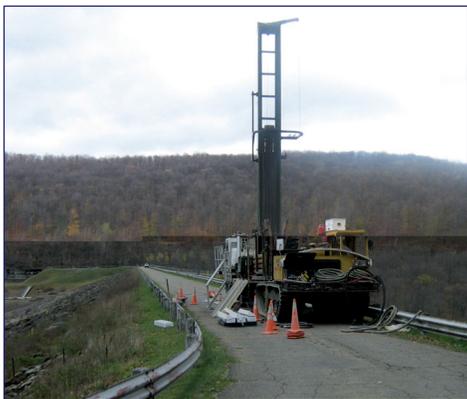
Drilling operations at East Branch Dam.

- A geophysical study using Willowstick Technologies AquaTrack™ methodology to identify preferred seepage paths through the dam.
- Conventional borings, sonic-drilled borings and cone penetration test

(CPT) soundings through the dam embankment, right abutment and native foundation materials.

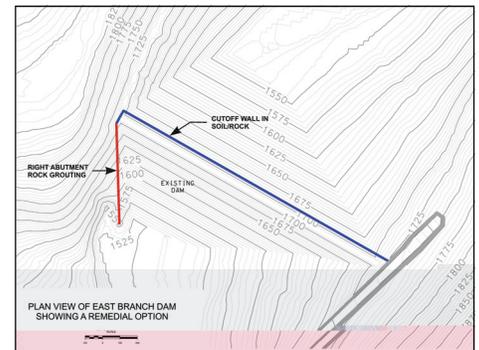
Plan drawing showing a proposed alternative for remediation of seepage conditions at East Branch Dam.

- Partial-length cutoff wall with grout curtain in bedrock
- Full-length cutoff wall with grout curtain in bedrock
- Upstream slope seepage barrier with upstream foundation cutoff
- Dam extension and fortification
- Operation at reduced maximum summer pool
- Complete removal of the existing dam

For each of the considered alternatives, the estimated construction quantities, anticipated schedule requirement, and advantages and disadvantages were determined for comparison purposes. The USACE Pittsburgh District is currently conducting an internal evaluation of the alternatives in order to determine which of the proposed remedial alternatives will be implemented.

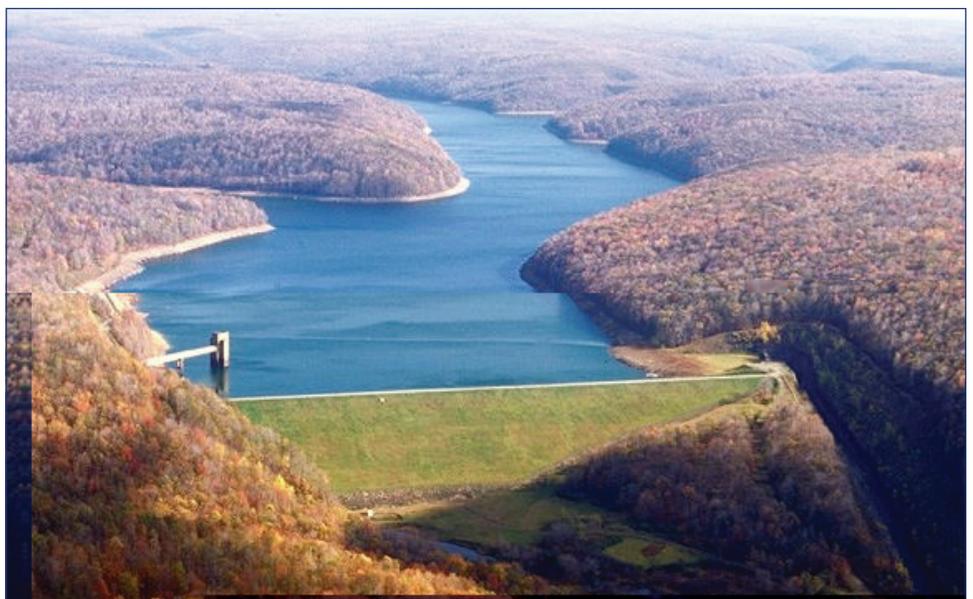
Aerial photograph of East Branch Dam.

East Branch Dam is a compacted earth-fill structure with the primary spillway tunnel passing beneath the right abutment and the emergency spillway channel cutting through the left abutment and adjacent hillside. The dam was designed to have a central core zone and cutoff trench, but, as constructed, is generally homogeneous in nature.
