# PROJECT PROFILE

## BLUFF STABILIZATION ALONG MISSISSIPPI RIVER NEAR HICKMAN, KENTUCKY

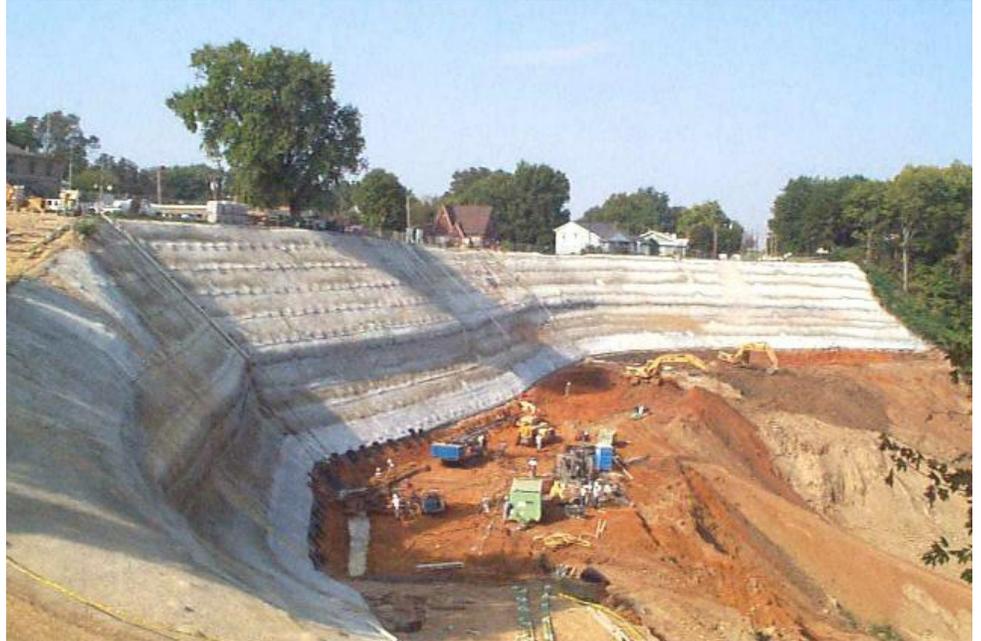
*150-foot-high bluff situated along the Mississippi River during construction of a 95,000-square-foot stabilization system that incorporates soil nails and prestressed soil anchors.*

The selected design consisted of a tiered soil-nailed (1H:1V) slope. The

soil-nailed slope was tiered to allow for construction of a reinforced soil slope in order to re-establish the crest of the bluff and to allow for reconstruction of the road at the crest. The design incorporated horizontal drains to control the ground water in the sand and gravel stratum and prestressed soil anchors to provide additional stability against global slope failures.

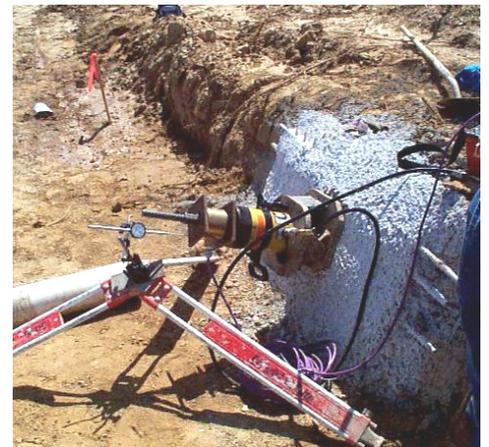
*Pre-production soil nail load test.*

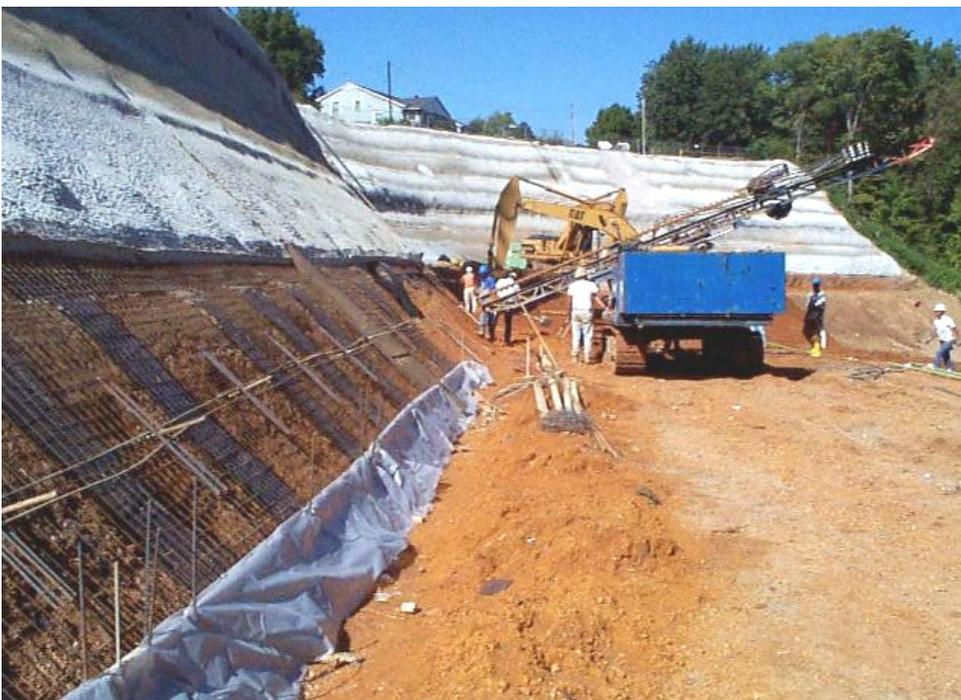
*Drilling for installation of one of over 1,500 soil nails used in the stabilization system.*
