PROJECT PROFILE

BLUFF STABILIZATION ALONG MISSISSIPPI RIVER NEAR HICKMAN, KENTUCKY

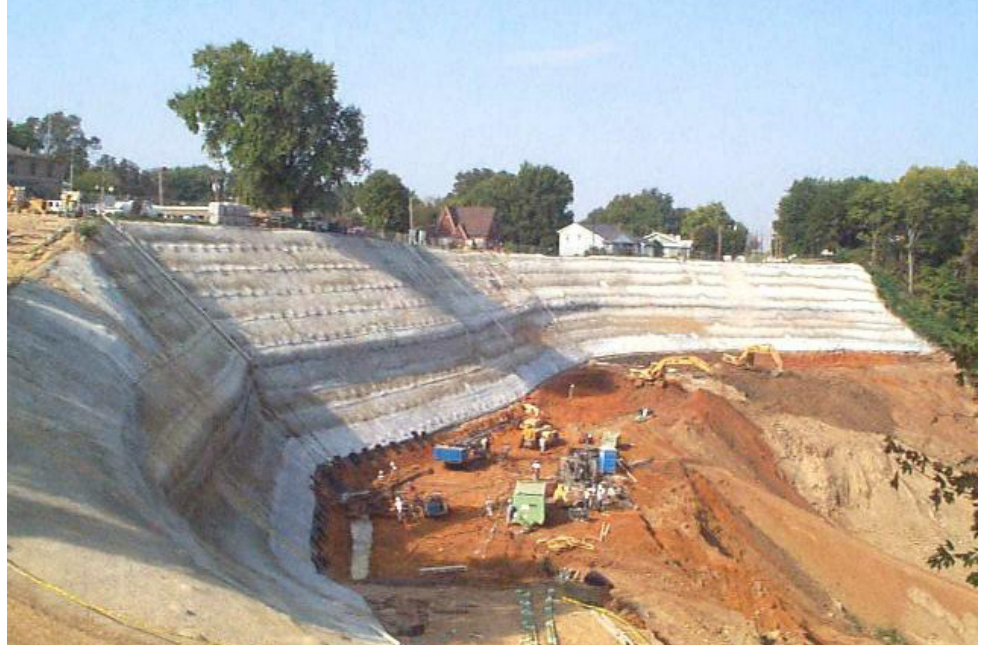
150-foot-high bluff situated along the Mississippi River during construction of a 95,000-square-foot stabilization system that incorporates soil nails and prestressed soil anchors.

The selected design consisted of a tiered soil-nailed (1H:1V) slope. The

soil-nailed slope was tiered to allow for construction of a reinforced soil slope in order to re-establish the crest of the bluff and to allow for reconstruction of the road at the crest. The design incorporated horizontal drains to control the ground water in the sand and gravel stratum and prestressed soil anchors to provide additional stability against global slope failures.

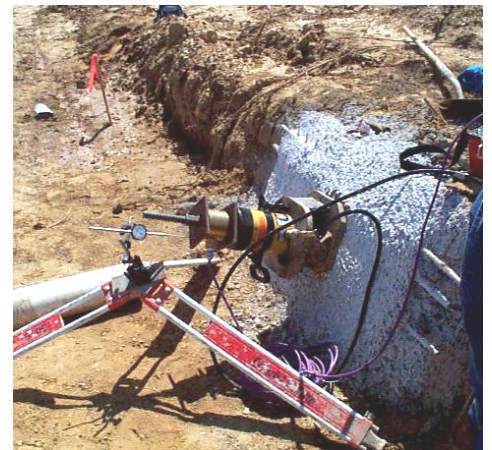
Pre-production soil nail load test.

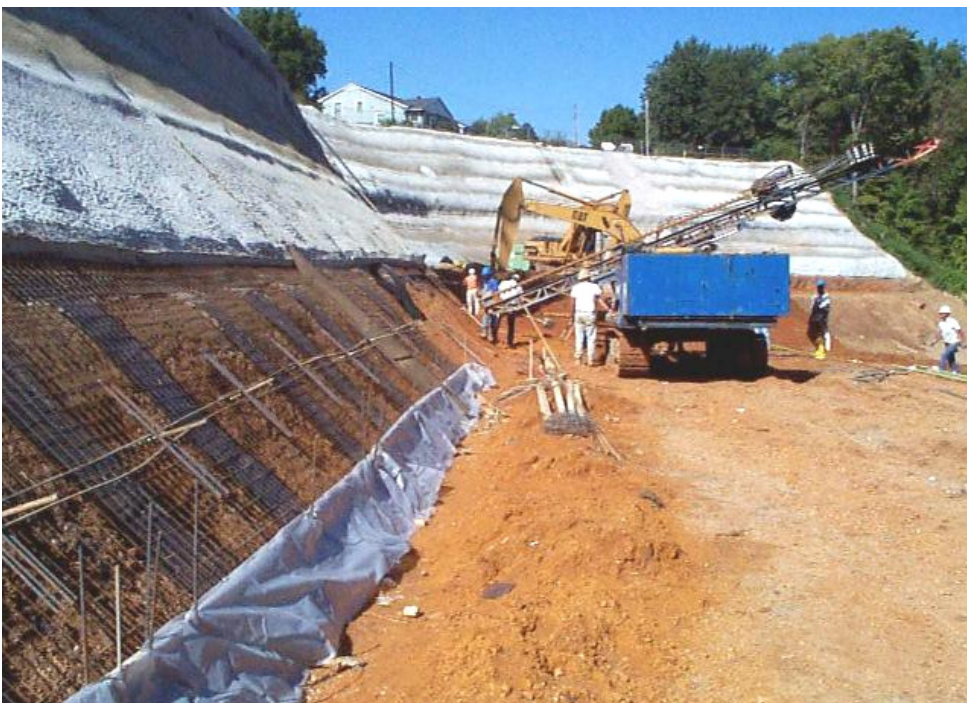
Drilling for installation of one of over 1,500 soil nails used in the stabilization system.
