PROJECT PROFILE

RCRA FACILITY SITE ASSESSMENT, PERMITTING, MONITORING AND CLOSURE

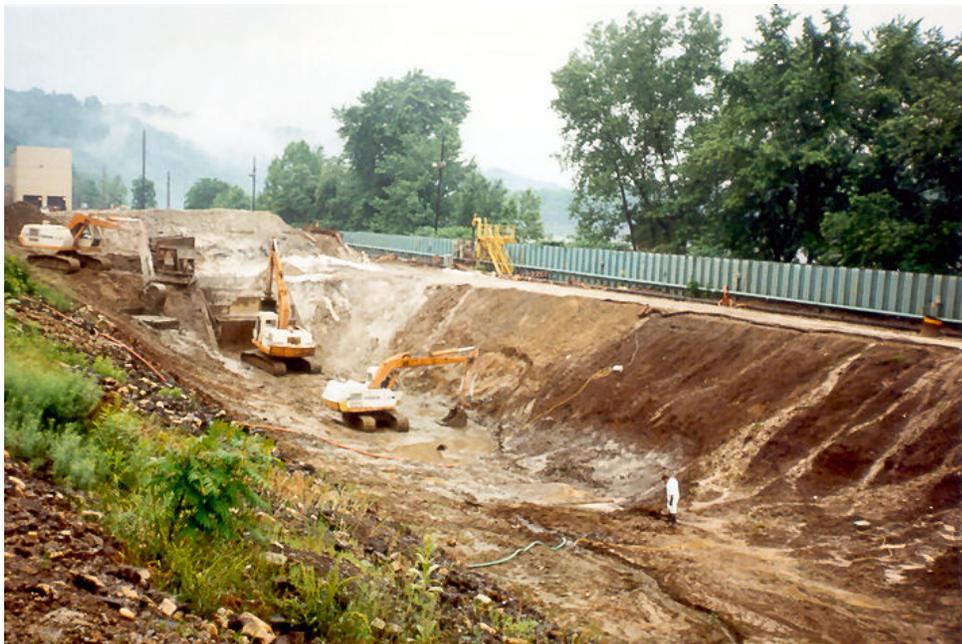
Hazardous waste settling lagoon during closure. Sludge is being removed for stabilization and off-site disposal. The Ohio River is on the opposite side of the sheet piling.

Following construction of a wastewater treatment facility, we developed a lagoon closure plan, including engineering design, permit preparation and construction monitoring. The closure plan consisted of (1) dewatering the lagoons; (2) removing, stabilizing, and disposing of sludge off site; (3) field and lab testing of metals concentrations in the bottom soils; (4) placing engineered fill over the former lagoons; (5) installing a clay cap system; and (6) constructing drainage controls. Based on the ground

water monitoring data and the low mobility of metals exhibited in underlying soils, excavation for closure was limited to removal of the lagoon sludge and minimal removal of bottom soils. Because the facility was in the floodplain of the Ohio River and sludge and soils were excavated from elevations below river level, a surface drainage system and a series of dewatering wells were required. Ground water pumped from the dewatering system was discharged to the wastewater treatment plant at the site.
