PROJECT PROFILE

EVALUATION OF PYRITIC SHALE EXPANSION AT A MANUFACTURING PLANT

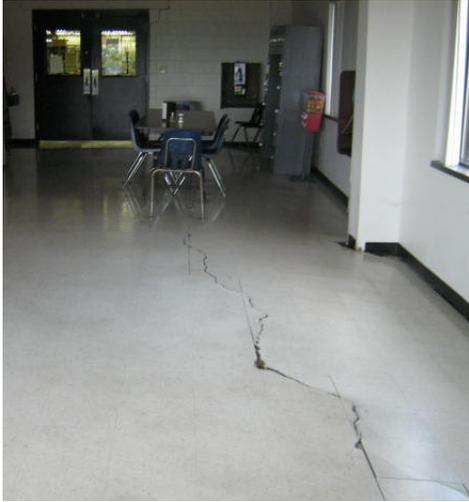
Observed heave and cracking of the floor at manufacturing plant.

Heave and cracking of floor slabs and interior partition walls in the southeastern portion of the building were reported within a year following completion of construction and have subsequently continued for more than 10 years. Floor slabs now exhibit elevation changes of more than 4 inches over short distances and abrupt elevation changes with respect to building column piers. Interior masonry wall cracking has progressed to the extent that there is some concern over future stability of these walls.

D'Appolonia developed recommendations for remediation of the structure. These included excavation of expansive material at the surface, sealing the exposed surface and backfilling with non-expansive material, and support of floors and partition walls on a system of new columns and grade beams. Preliminary costs for implementation of these recommendations were also developed.

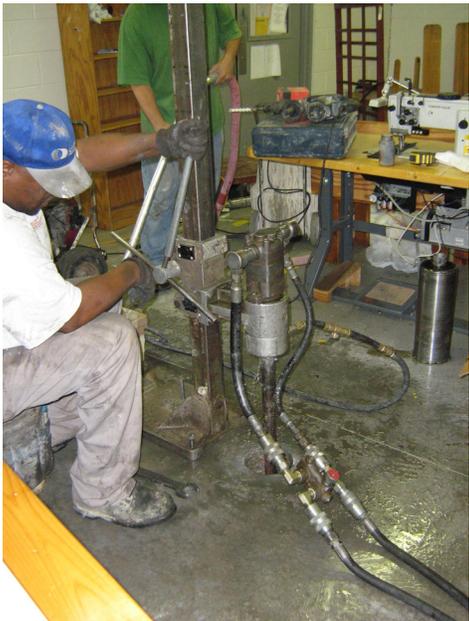
Drilling through interior floor slab.

D'Appolonia performed an extensive site reconnaissance, conducted an exploratory drilling and sampling program, and arranged for selected soil samples to be tested for total inorganic sulfur content. The results of the laboratory testing program indicated sulfur contents ranging up to 3.1 percent. Pyritic sulfur contents greater than 1 per-

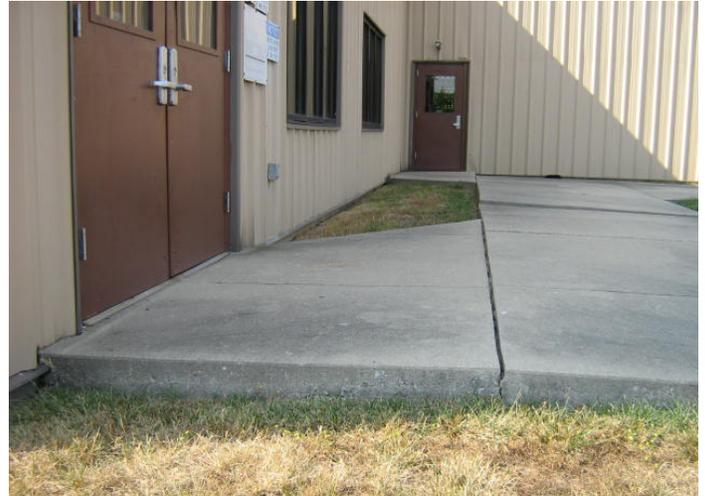
Heave in concrete slabs adjacent to building.

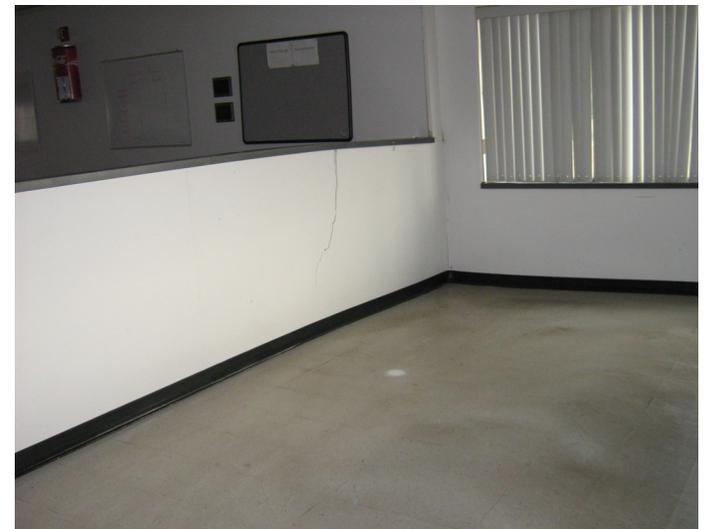
Deformation of floor and partition wall due to heave of shale.

materials was about 12 percent, indicating that there was potential for considerable additional heave of the underlying shale bedrock.
