# PROJECT PROFILE

## HIGHLAND PARK RESERVOIR EMBANKMENT REPAIR

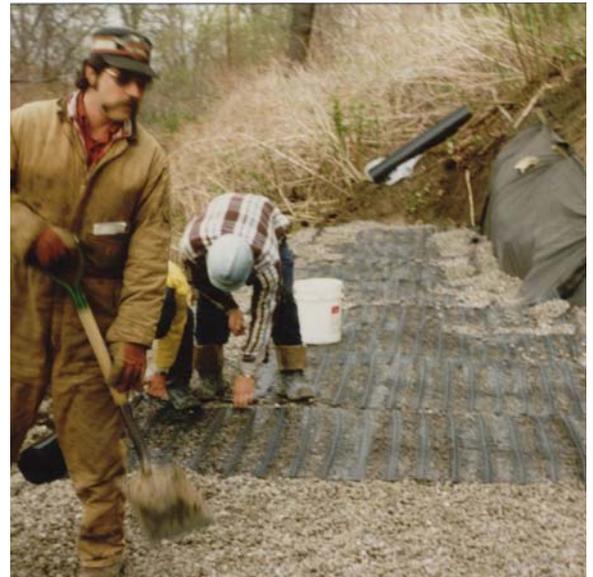
*Placement of geogrids during reconstruction of the reservoir slope and bench for railroad track.*

D'Appolonia was retained by the City of Pittsburgh Department of Engineering (City) to perform a subsurface exploration program and to develop corrective measures for the bench supporting the railroad. D'Appolonia designed and supervised the construction of a geogrid-reinforced granular buttress to remediate the damaged slope and restore the bench on which the railroad track was located.

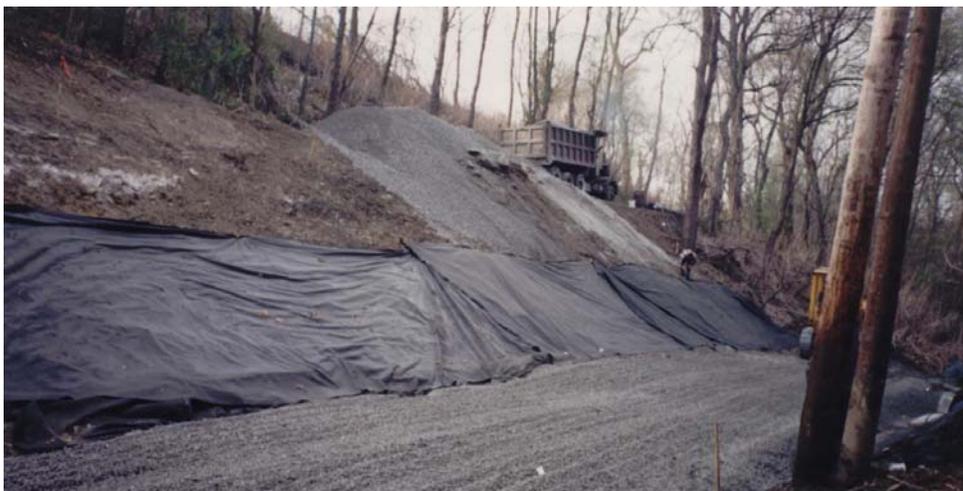
In 1987, the reservoir was drained to remove sediment from the bottom and to repair the concrete liner. As the reservoir was subsequently being refilled in 1988, a failure occurred along the downstream slope of the embankment, resulting in the destruction of a 160-foot segment of the zoo railroad, which was located on a bench approximately halfway down the impoundment slope from the crest. The failure was apparently caused by elevated ground water levels in the downstream face of the embankment resulting from seepage.

*Reconstruction of 160-foot-long section of failed reservoir embankment.*
