# PROJECT PROFILE

## BLUE TRAIL LANDSLIDE STABILIZATION ON U.S. ROUTE 26/89 IN WYOMING

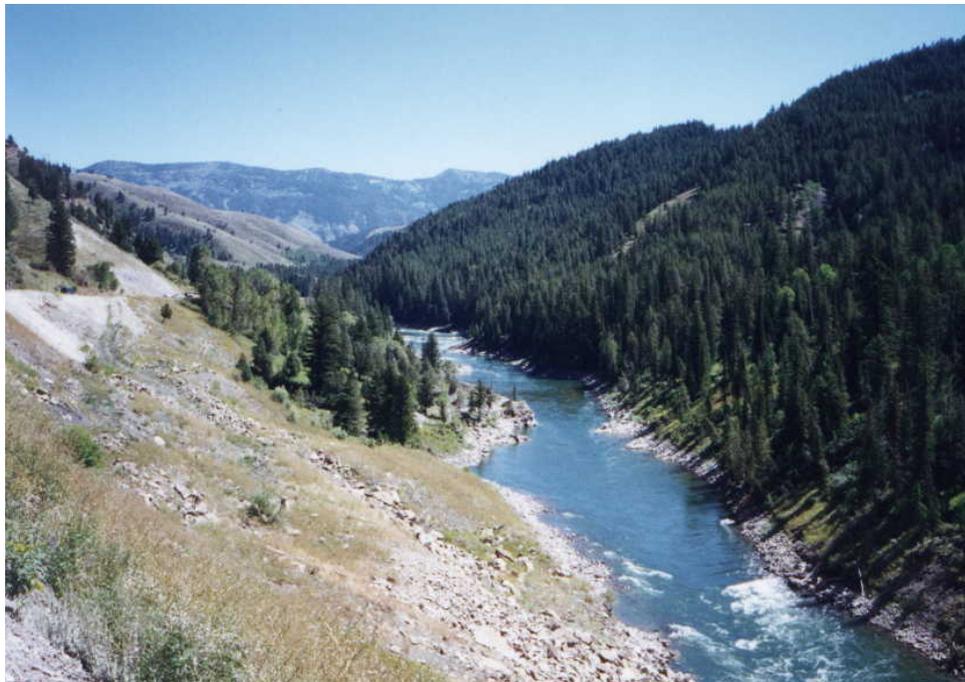
*Pre-construction photograph showing the physical constraints at site.*

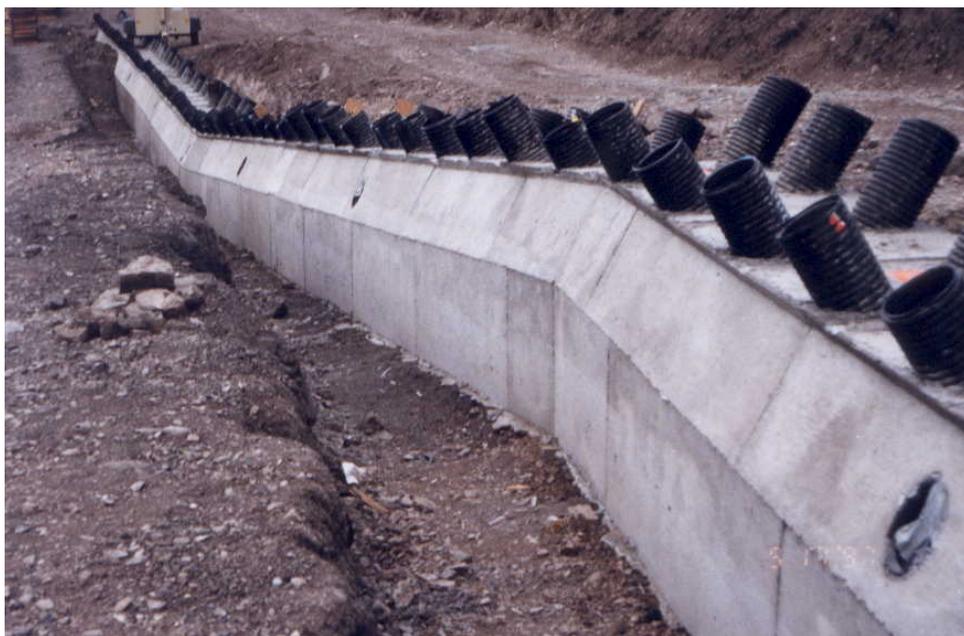
*Reinforced concrete cap beam showing access for micropiles and anchors.*

As the engineer/designer for Hayward Baker, Inc., D'Appolonia developed a repair scheme incorporating a three-tiered configuration of reticulated micropile walls. The walls consisted of uphill and downhill battered micropiles extending to below the slide surface and socketed in bedrock. At the ground surface the micropiles were connected by a continuous cast-in-place, reinforced-concrete cap beam. Prestressed 10- to 18-strand ground anchors were then placed through the cap beam and bonded into competent bedrock below the slide surface. Construction was performed along very steep slopes on an active landslide.

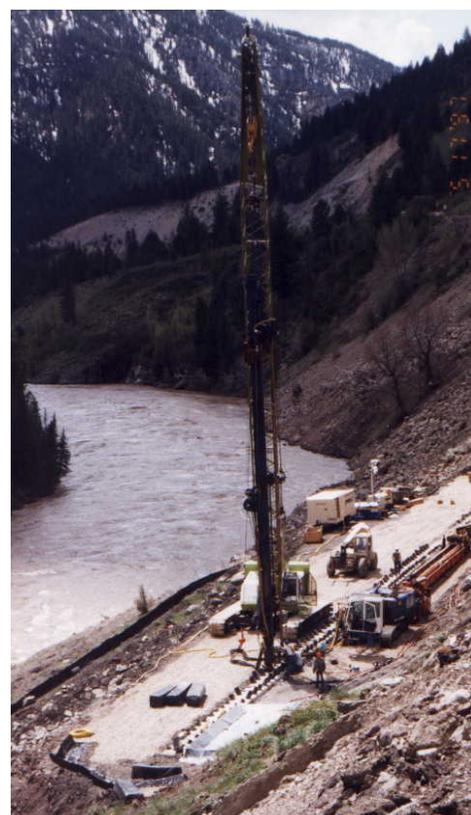
*Micropile drilling operation.*
